CHURCH OF THE HOLY SEPULCHRE JERUSALEM

STRUCTURAL SURVEY
FINAL REPORT

WILLIAM HARVEY

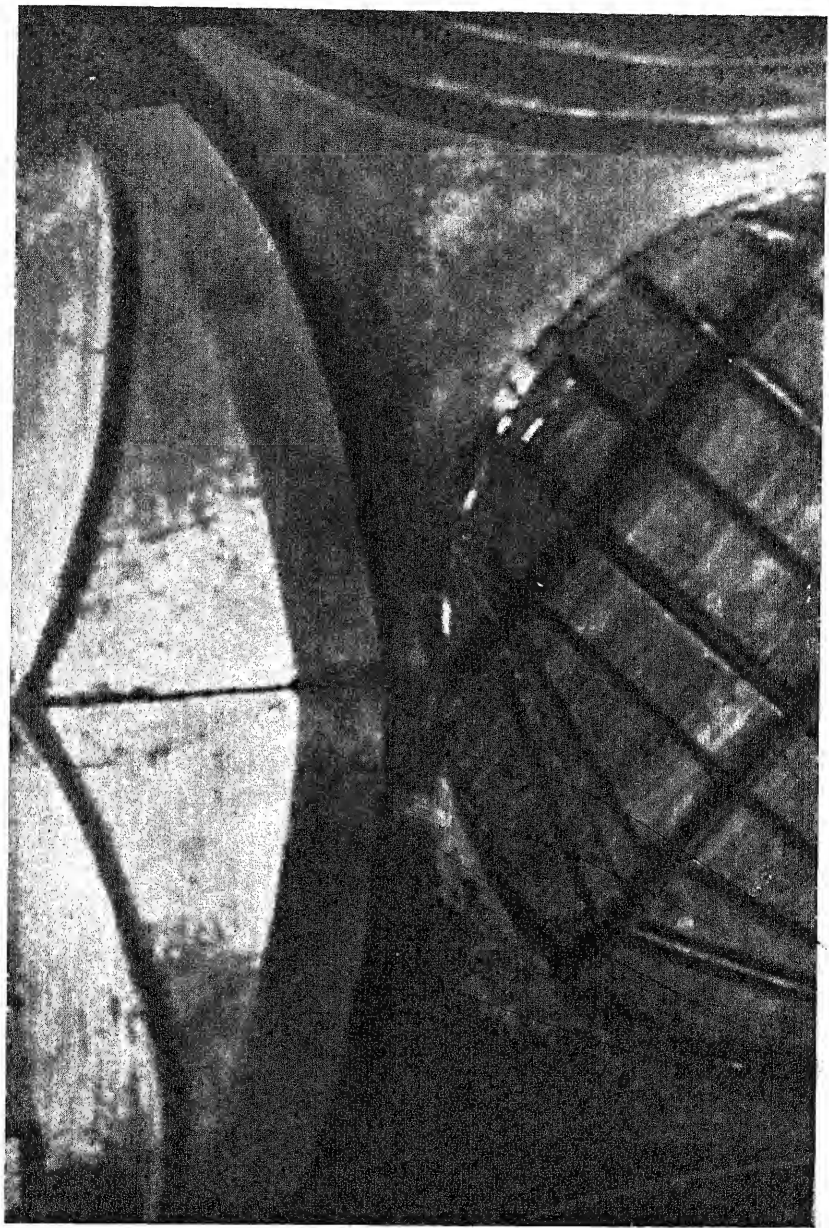
FIG. 1. EASTERN PENDENTIVES FROM BENEATH

The thrust is first communicated in a direction both downward and outward to the pendentives (see Figs. 1, 2, II, 24) supported on the four great arches of the crossing. It is to the position of the dome above the pendentives that the outward thrusts must be ascribed (see Fig. II).

The pendentives (see Figs. 1, 2, II, 24) receive the weight of the dome and transmit it to the four main piers below, but there is also considerable outward thrust, as the pendentives are not vertical, but inclined inwards to the bottom of the drum above. They were completely plastered over after the fire of 1808, and do not themselves show signs of great movement, except in the North-west pendentive, which is badly cracked. The piers below have decided leans outwards in the upper portions, and from this inclination the further parts of the building have received the damaging thrusts (see Additional Notes, p. 14).

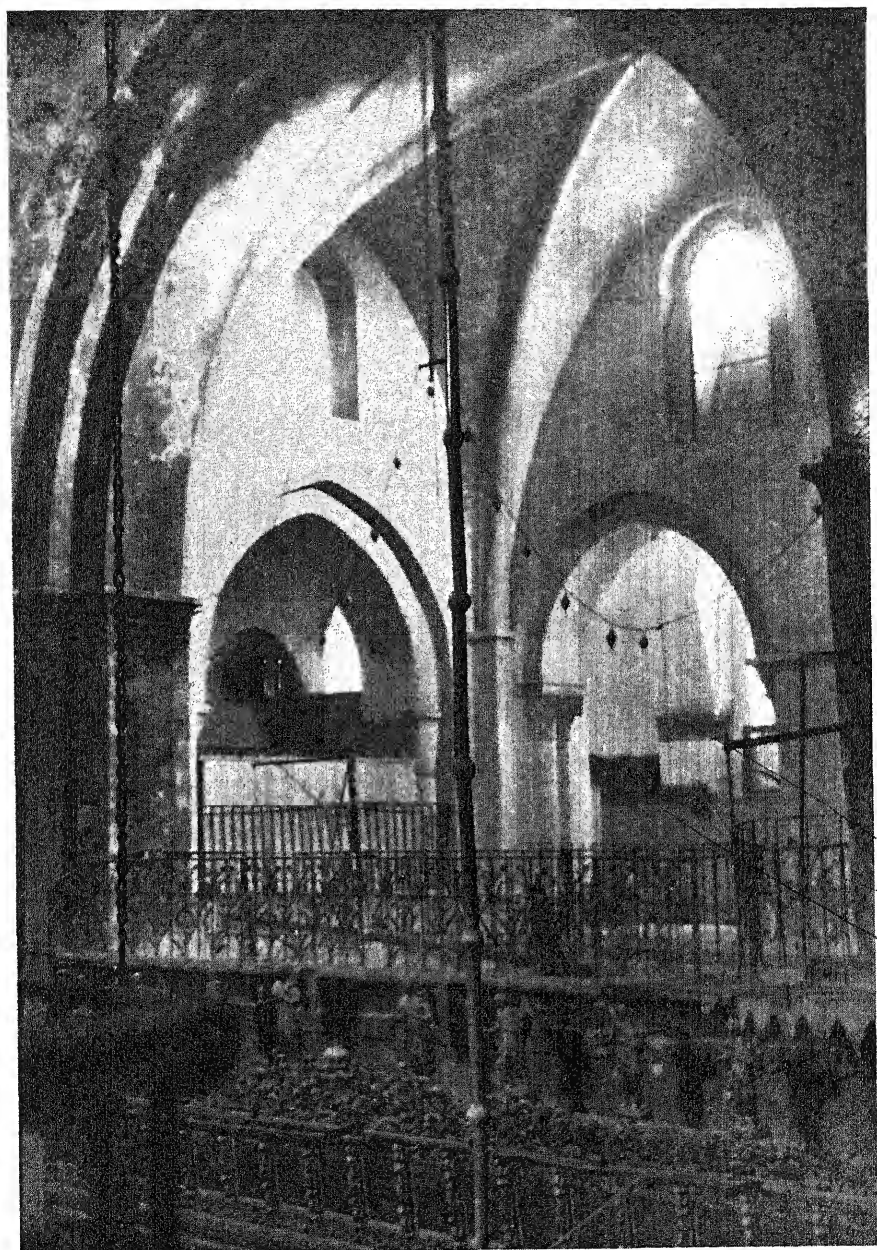
FIG. 3. NORTH TRANSEPT HIGH VAULT FROM S.E.

The North Transept proper consists of only one bay, with a vault above the main springing level of the great arches, and consequently occupying the same vertical space as the pendentives of the dome (see Figs. 3, I, 3). To the north of this bay is a gallery with two floors (see Fig. II, 9)—both originally of Byzantine construction; the lower vault (see Fig. 4) being below the Triforium arcades of the Transept proper. The upper vault (see Fig. 5) is above the Triforium, while leaving a clerestory lighting the high vault of the Transept above (see Fig. 6). This higher vault of the gallery is therefore in a position to receive

the full thrust of the springing of the high vault (see Fig. 3) which it communicates to the North wall of the gallery, here an exterior wall of the Church. This wall contains the most dangerous evidence of movement in the building (see Fig. IV). For the lower half of its height, its outward inclination is approximately 1 in 60, but above this, for three metres below the sills of a series of windows lighting the upper gallery, it becomes rapidly sharper, reaching 1 in 20 and even 1 in 16. This is the more serious in that this upper walling contains work of several periods, ill bonded together, and much of the mortar has disappeared (see Fig. 7).

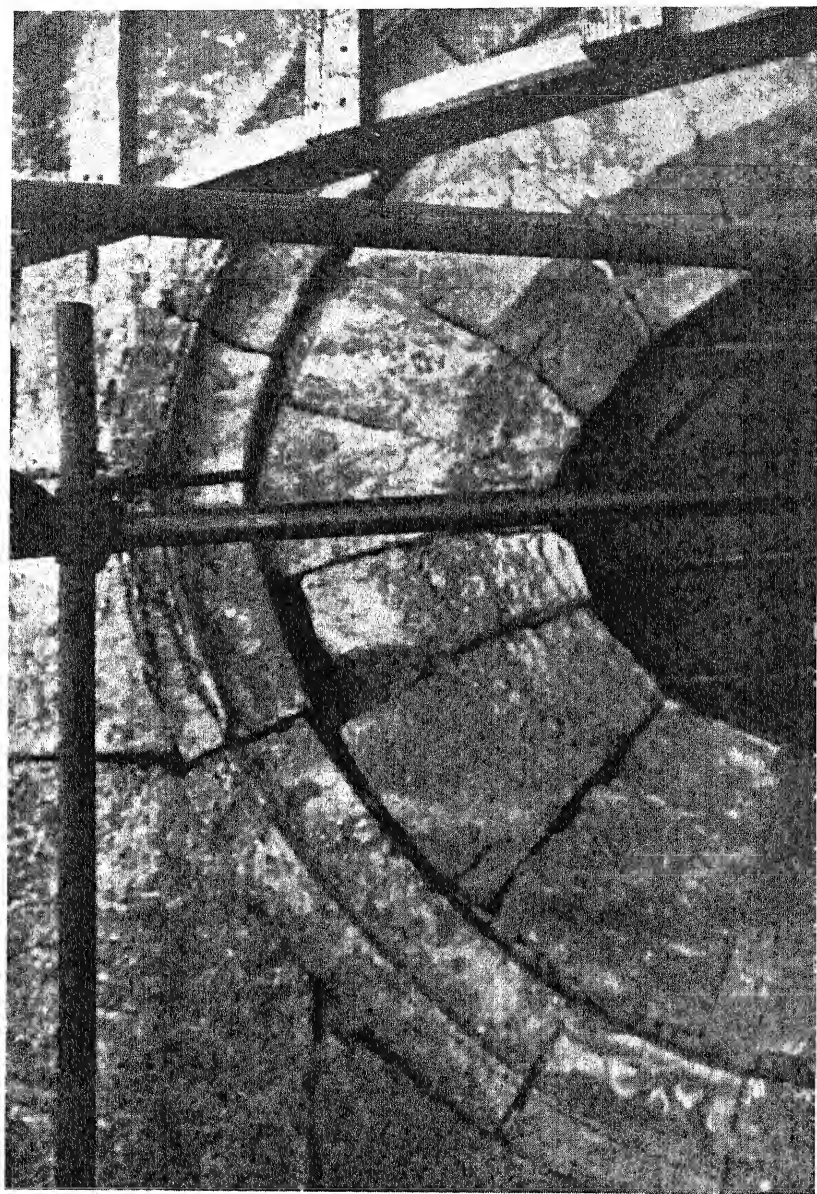
FIG. 8. A WINDOW-HEAD—NORTH WALL

Several instances occur of wide open joints penetrating through more than half the thickness of the wall, while the inner courses of voussoirs to the window arches have fallen downwards, leaving a wide space below the higher masonry (see Fig. 8). As the wall is restrained at each end by other buildings, leaving less than thirteen metres free to move outwards, such a grave inclination in the centre has resulted in great curvature of the wall-top (see Fig. 9) and this, together with the overhang and poor state of the mortar joints, may at any time allow the fall of some of the facing stones—should this occur any attempt to save the rest of the wall would be extremely dangerous, and collapse of the high vaults behind might easily follow.

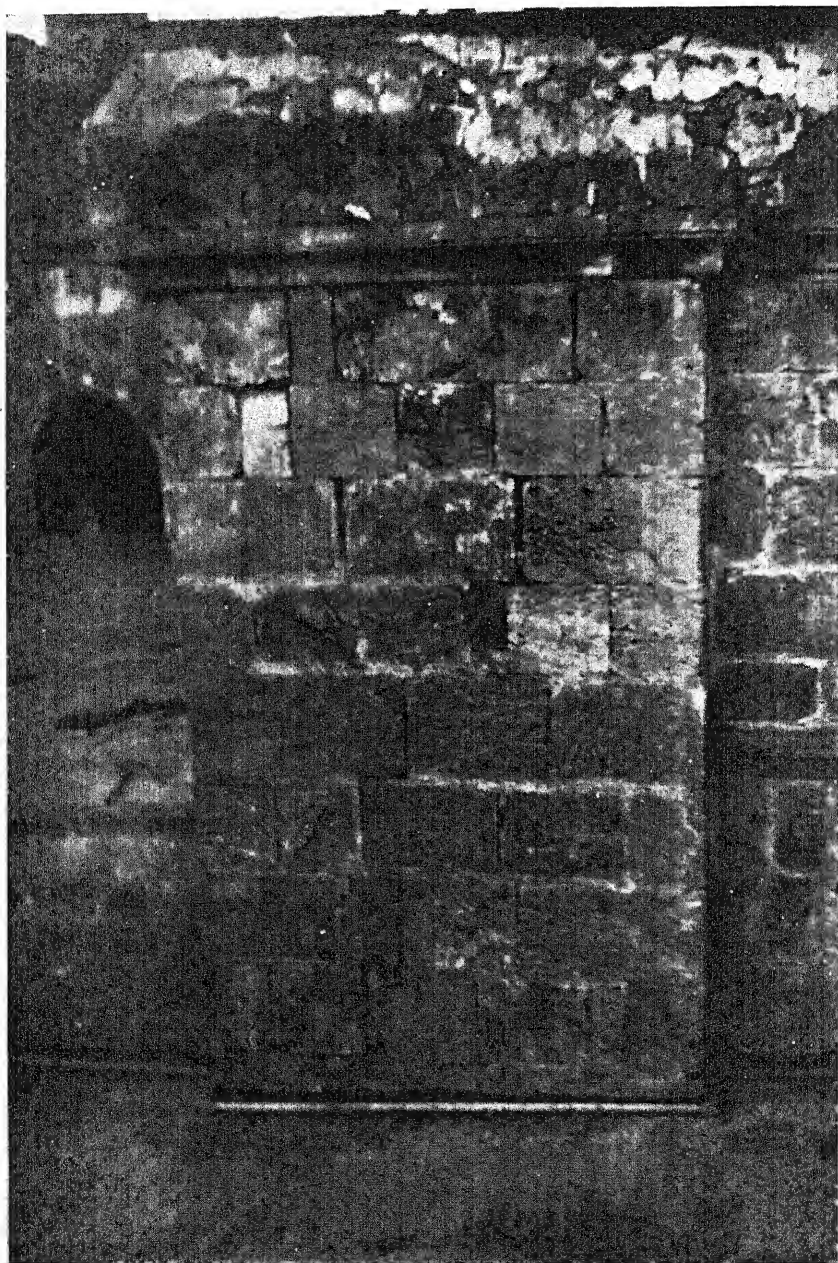
FIG. 12. N.E. CORNER OF NORTH TRANSEPT

The high vault itself (see Fig. 11) has also been plastered, but some two years ago a large stone fell from one of the main ribs, and the upper walls, where accessible from outside, are in an extremely poor condition (see Figs 12, 13, 14), many joints being completely denuded of mortar, and much of the masonry cracked and suffering from erosion, and to some extent from the effects of the fire of 1808.

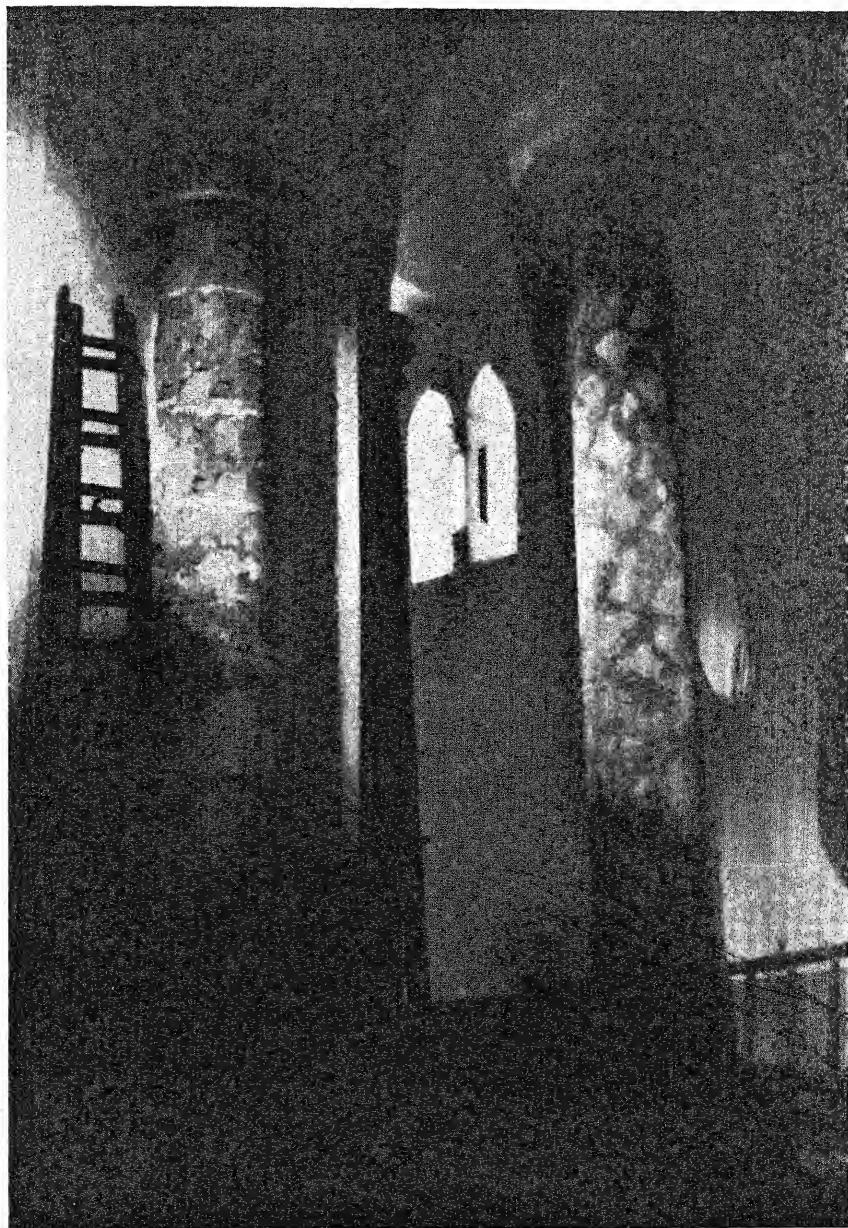
FIG. 15. E. COLUMN OF BYZANTINE ARCADE

The marble columns of the Byzantine arcade (see Fig. 15) are seriously cracked as a result of the thrusts, and of the great weight resting upon them. The cracks appear to be recent, and loose splinters of the marble can be detached.

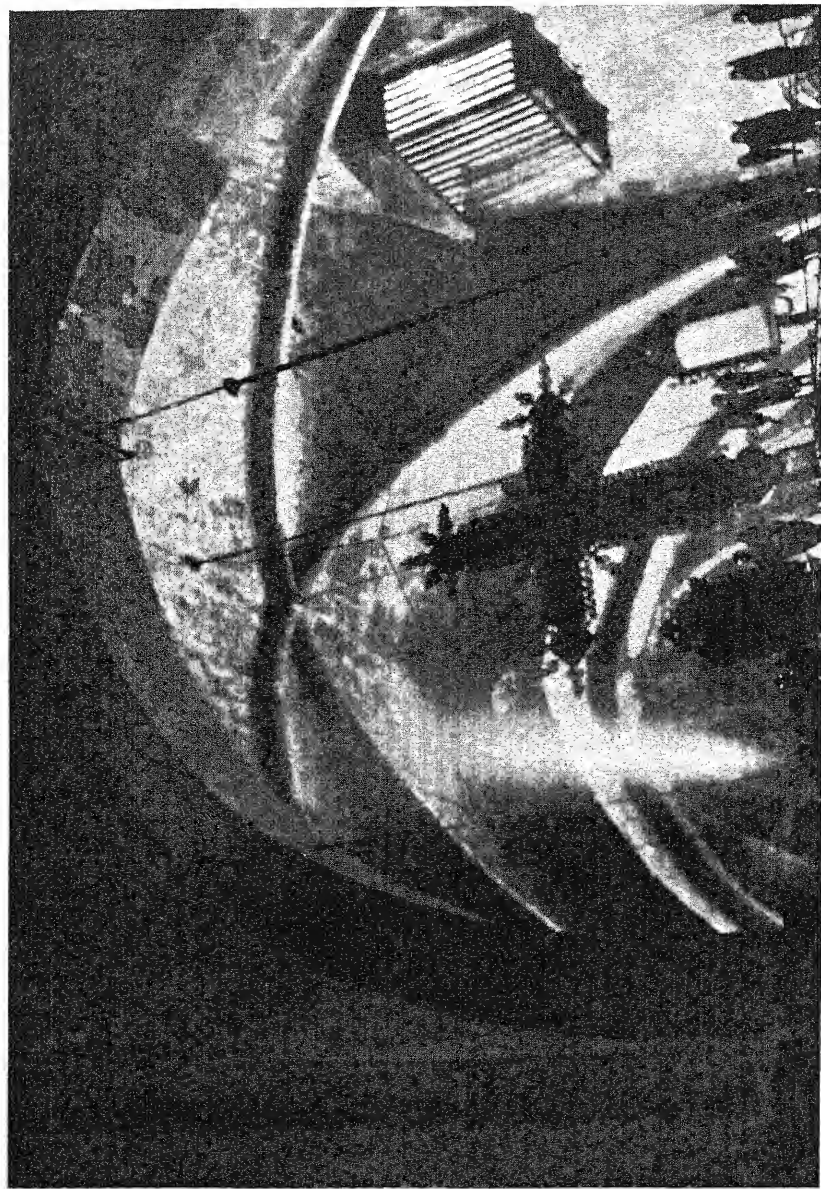
FIG. 16. EASTERN ARM HIGH VAULT FROM W.

The Eastern arm of the Church dates from the twelfth century, but the work is obscured by the plastering and additions of 1810 (see Figs. 16, 17, I, 5-II, 2). The apse (see Figs. I, 6-II, 3) is divided into two stories, of which the lower probably retains a twelfth-century core, while the upper is completely of the 1810 rebuilding. While the lower work remains upright, owing to the buttressing effect of many low vaults entirely surrounding it, the upper work is in a bad state of disrepair (see Fig. 18).

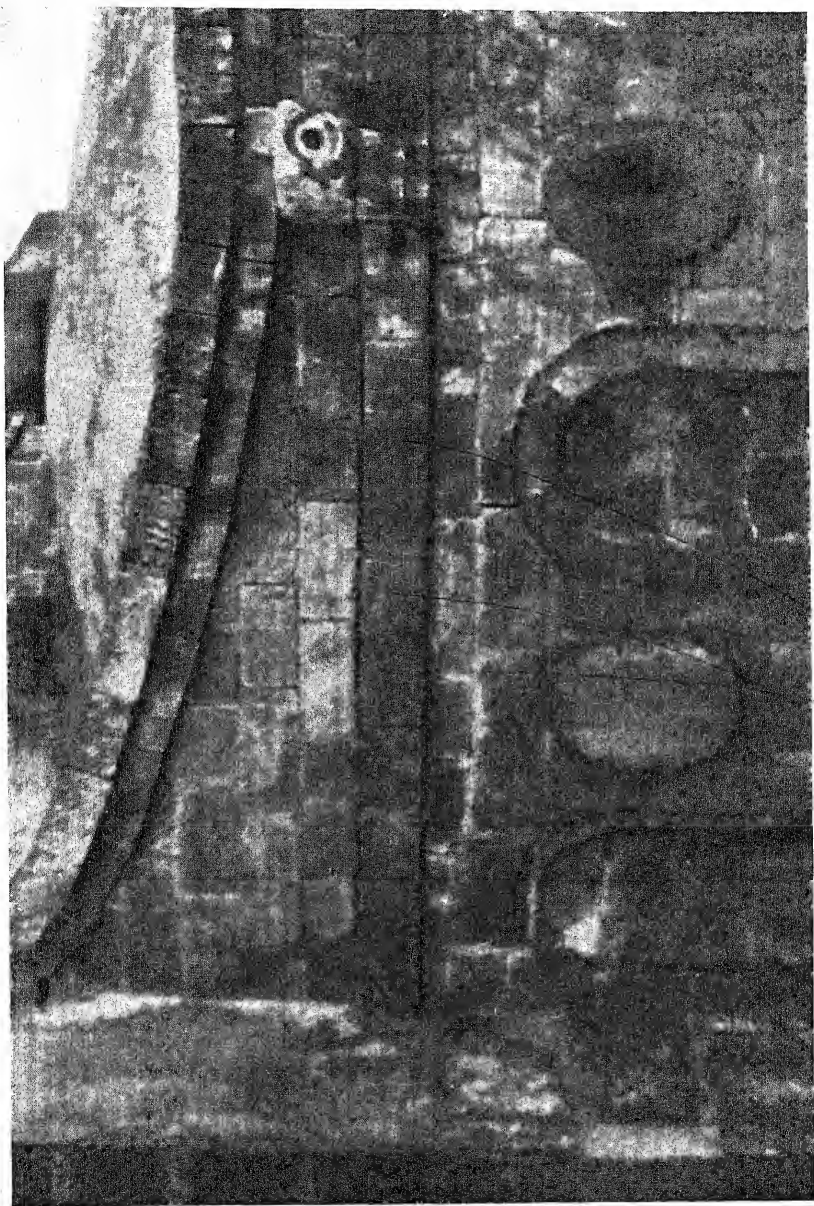
FIG. 19. APSE PARAPET

Near the apse roof, the bed-joints of several courses are devoid of mortar (see Fig. 19), and the parapet, unrestrained by any tie-bars, has moved outwards (see Fig. 20).

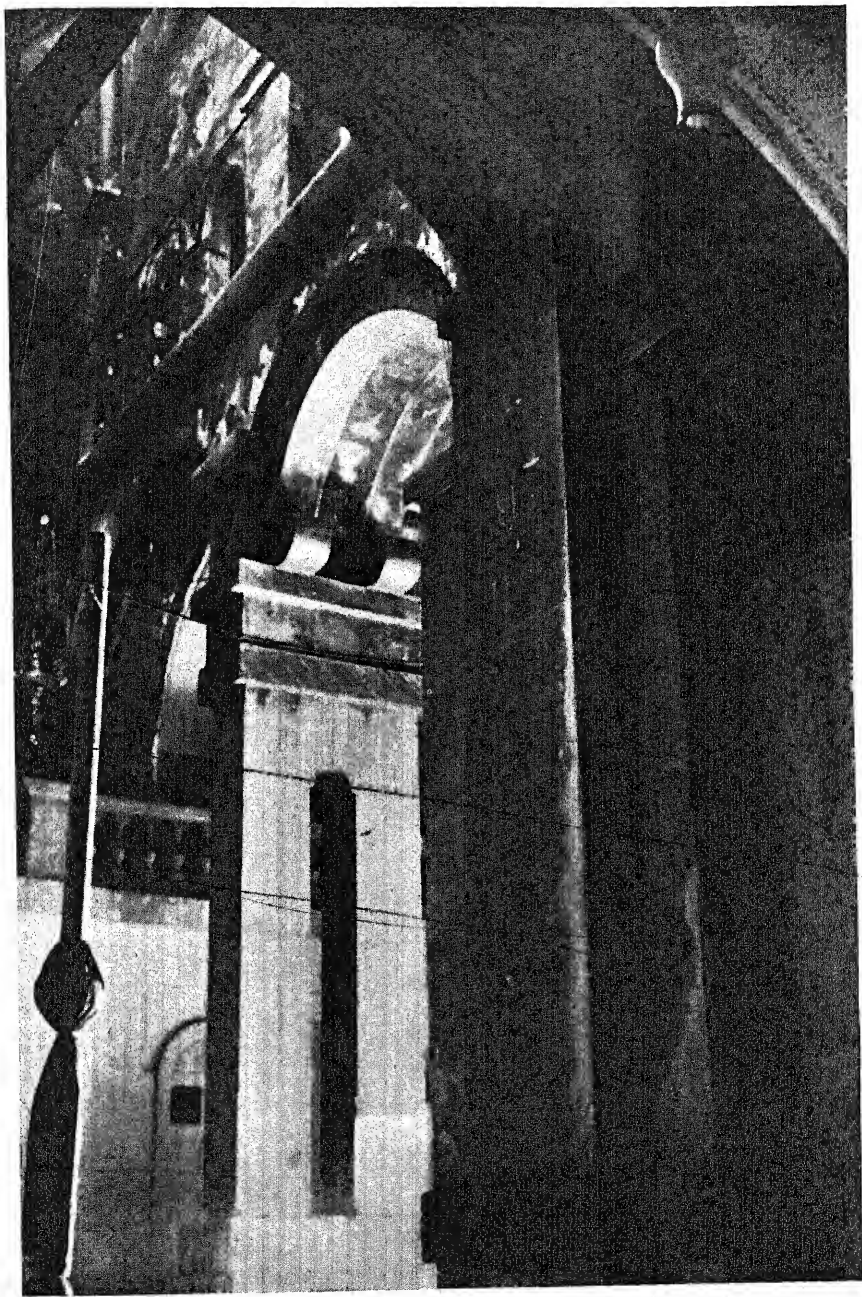
FIG. 21. SOUTH TRANSEPT FROM N.W.

The South Transept (see Figs. I, 1-II, 2), including the main front of the Church, contains much twelfth-century work; but the interior suffered greatly from the fire, and was partly rebuilt (see Figs. 21, 22, 23). The South wall shows very considerable calcining of the masonry, principally in the upper story, and a large proportion of the stonework is unfit to support the superincumbent weight and thrusts.

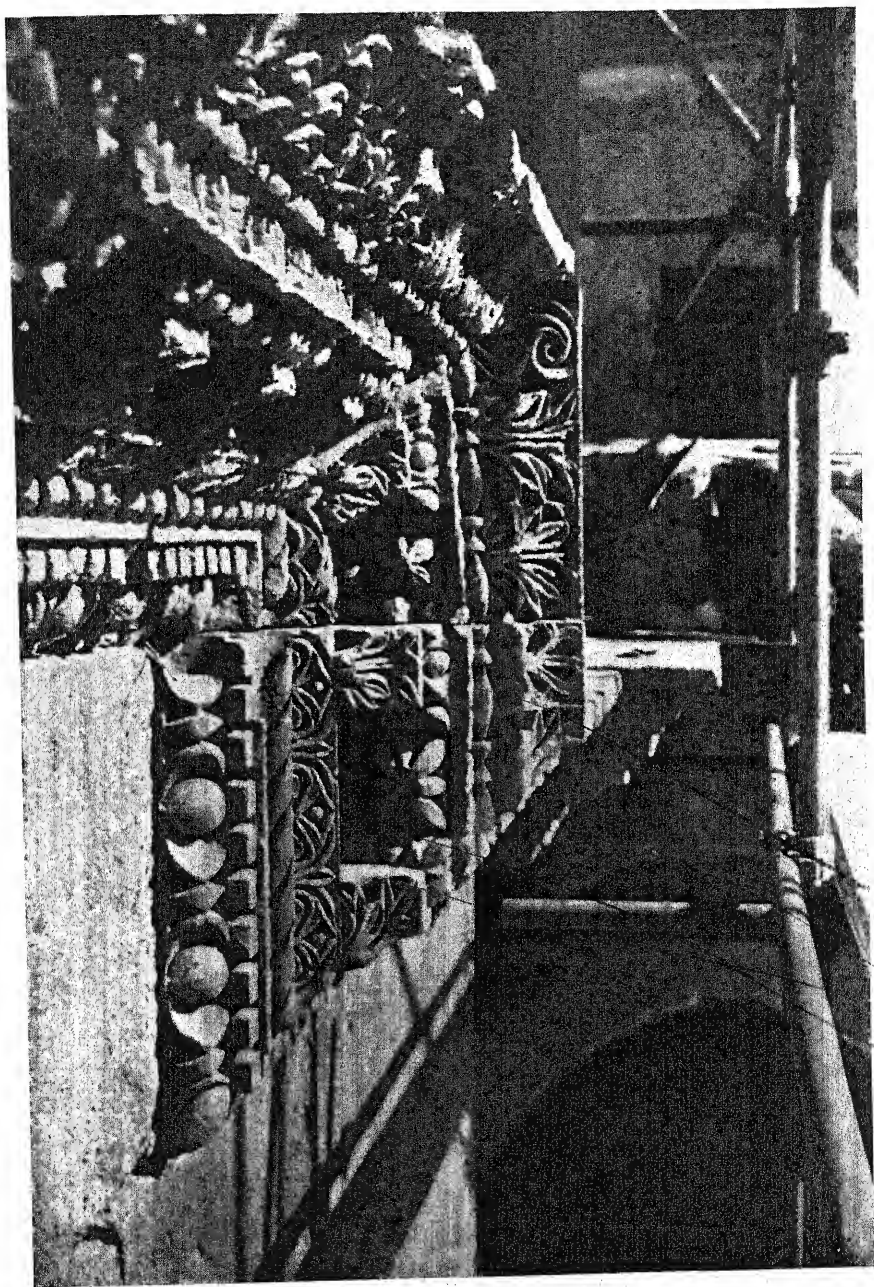
FIG. 25. MAIN FRONT—LOWER CORNICE

The lower colonnettes and their bases are almost all cracked, the oblique direction of the cracks showing the asymmetrical loading of the arches above (see Fig. 24). The condition of most of the carved work is extremely good (see Figs. 25, 26, 27, 28, 29) with the exception of the inner orders of the upper arches, which suffered most from the fire (see Figs. 30, 31, 32).

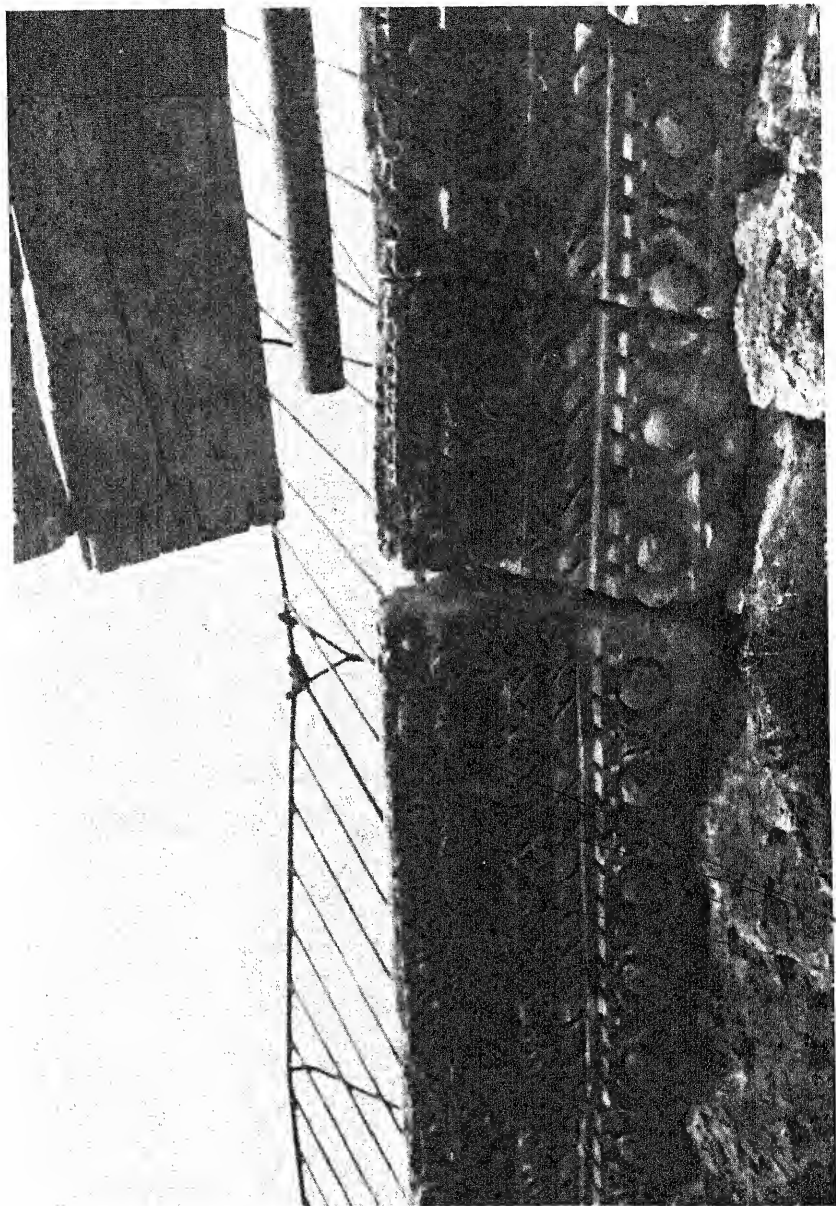
FIG. 33. DISLOCATED BLOCKS OF MAIN CORNICE

The main cornice at the wall top is greatly dislocated (see Figs. 33, 34) and harm has been done by the insertion of iron wedges and cramps which have caused cracking, due to rust (see Fig. 35).

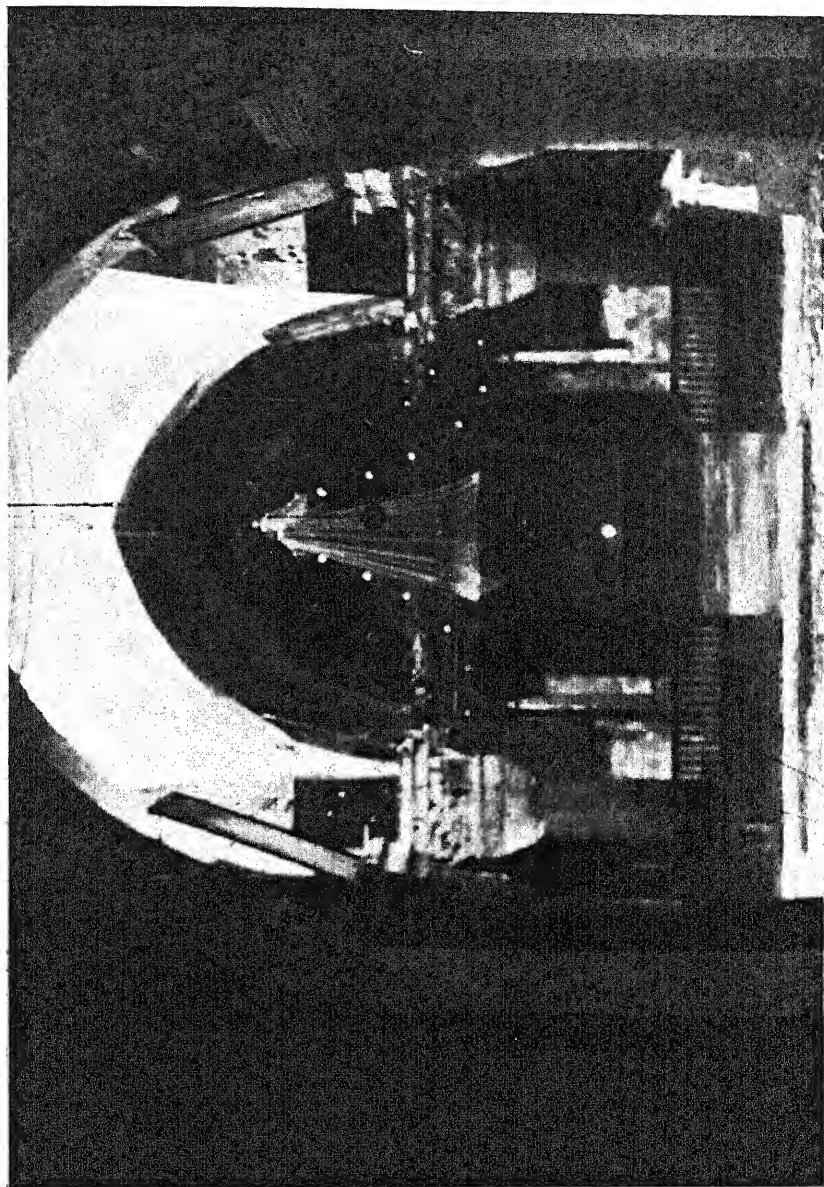
FIG. 44. ST. HELENA'S CHAPEL FROM W.

The Chapel of St. Helena (see Figs. 44, I, 28) lies below ground-level (see Fig. 45) and there is consequently but slight

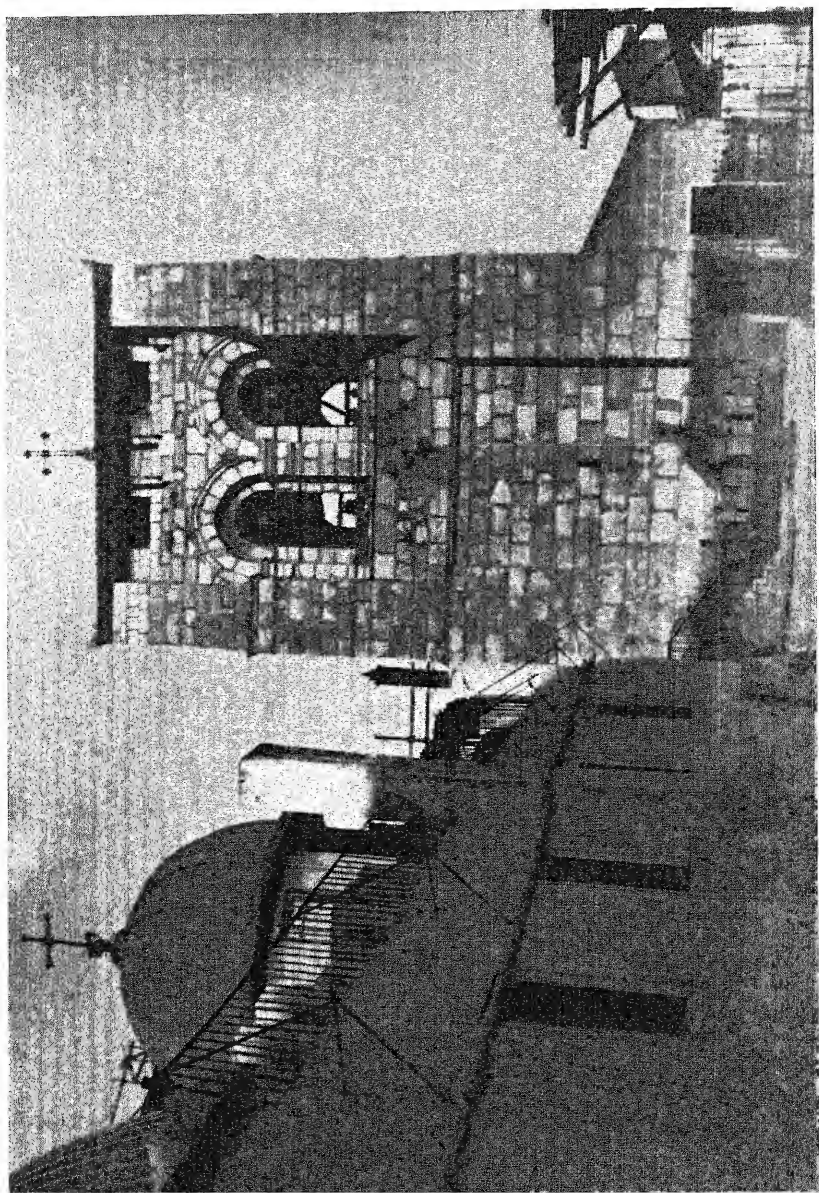
At the top the outward inclination is severe, and has affected the surrounding vaults and further walls (see Fig. 57).

Almost at the top is the small Chapel of St. Constantine (see Fig. II, 21); it is within this that the outer Rotunda wall shows its worst leans, which are also easily perceptible in the opposite South wall of the Chapel, which stands on the Convent roof (see Fig. 57). The condition of both walls at this level is serious, as large cracks in the surface stucco of the Chapel show.

FIG. 57. TOWER FROM W. AND CHAPEL OF CONSTANTINE

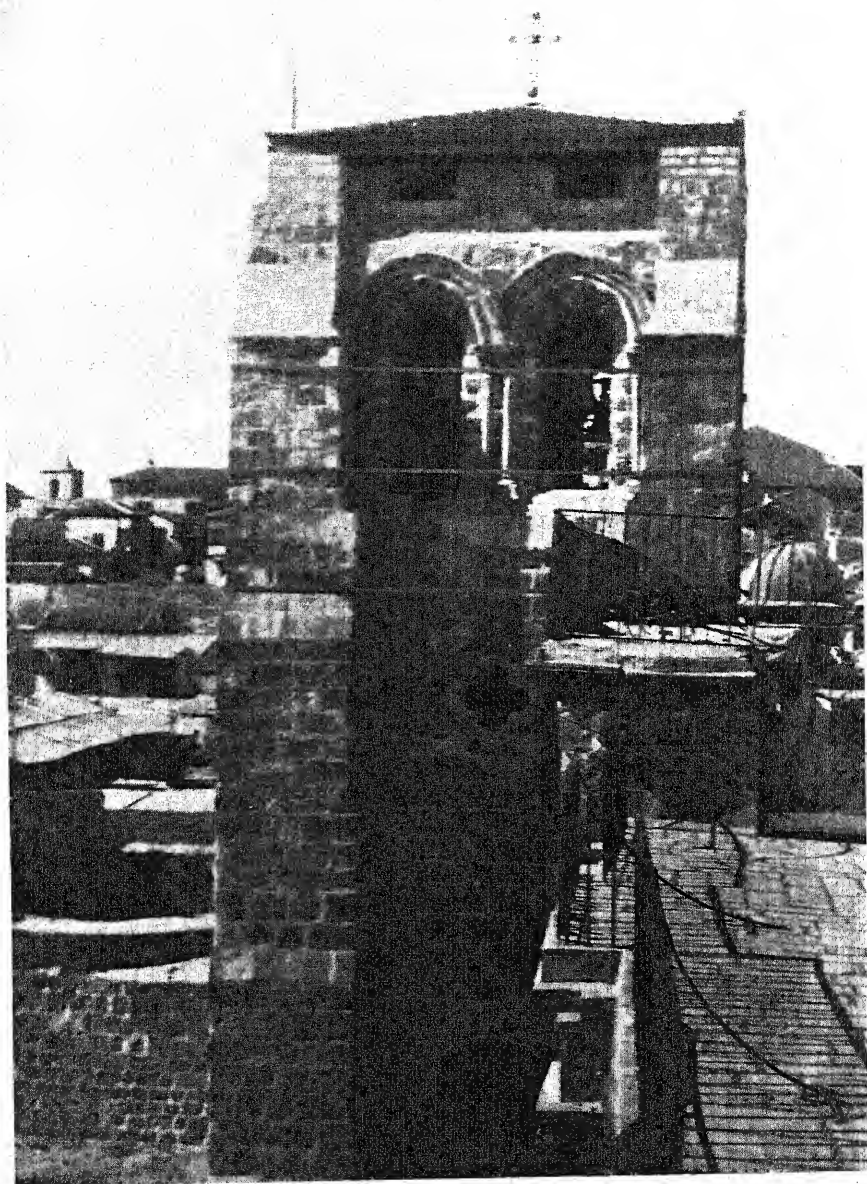
FIG. 58. TOWER FROM E.

Previously the roof had collapsed to the south in the earthquake of 1545, and carried with it the dome of the old Baptistery (see Fig. 58).

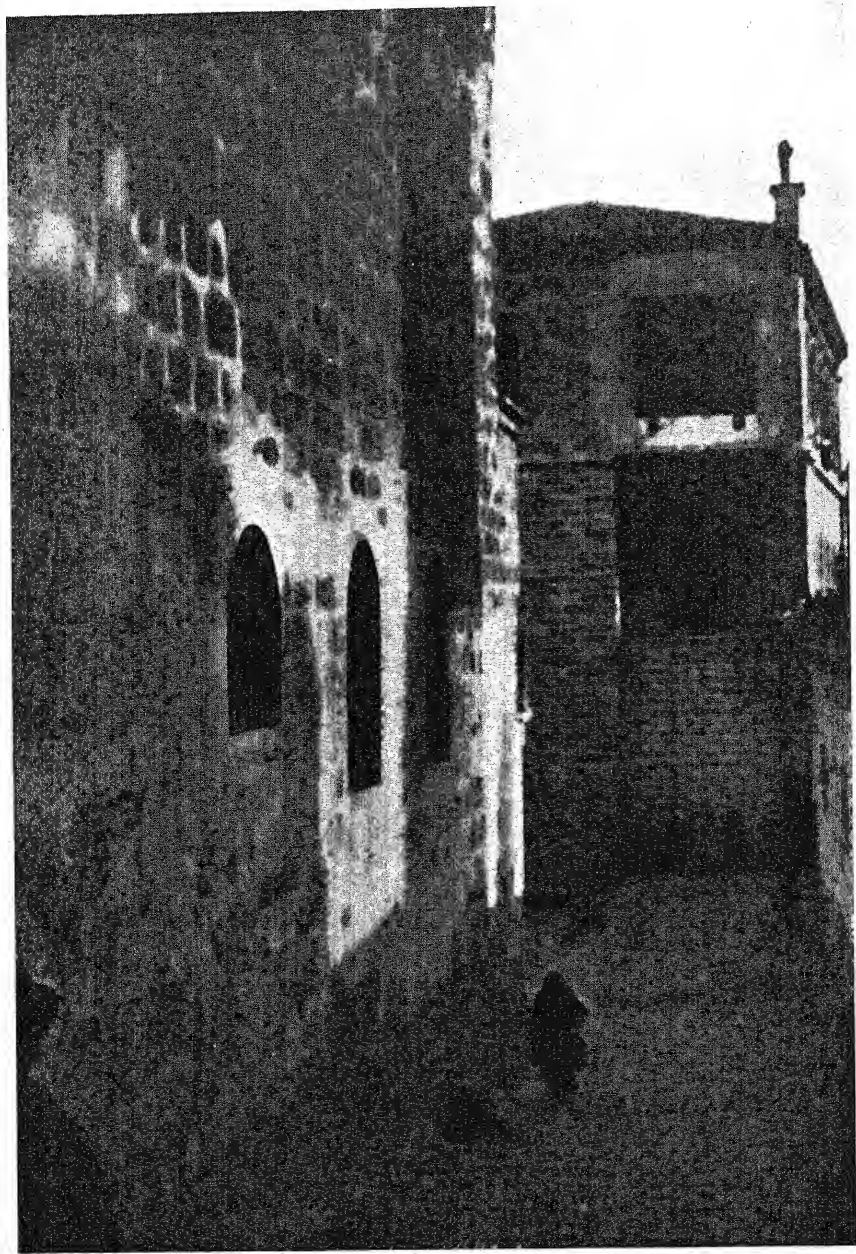
This Chapel is in a state of grave danger, as the lower half of its South wall (see Figs. 61, 62) overhangs the adjoining street

by $22\frac{1}{2}$ centimetres, and the crown of the vault is cracked throughout its length (see Figs. 63, V).

FIG. 61. SOUTH WALL OF CHAPEL OF ST. JAMES

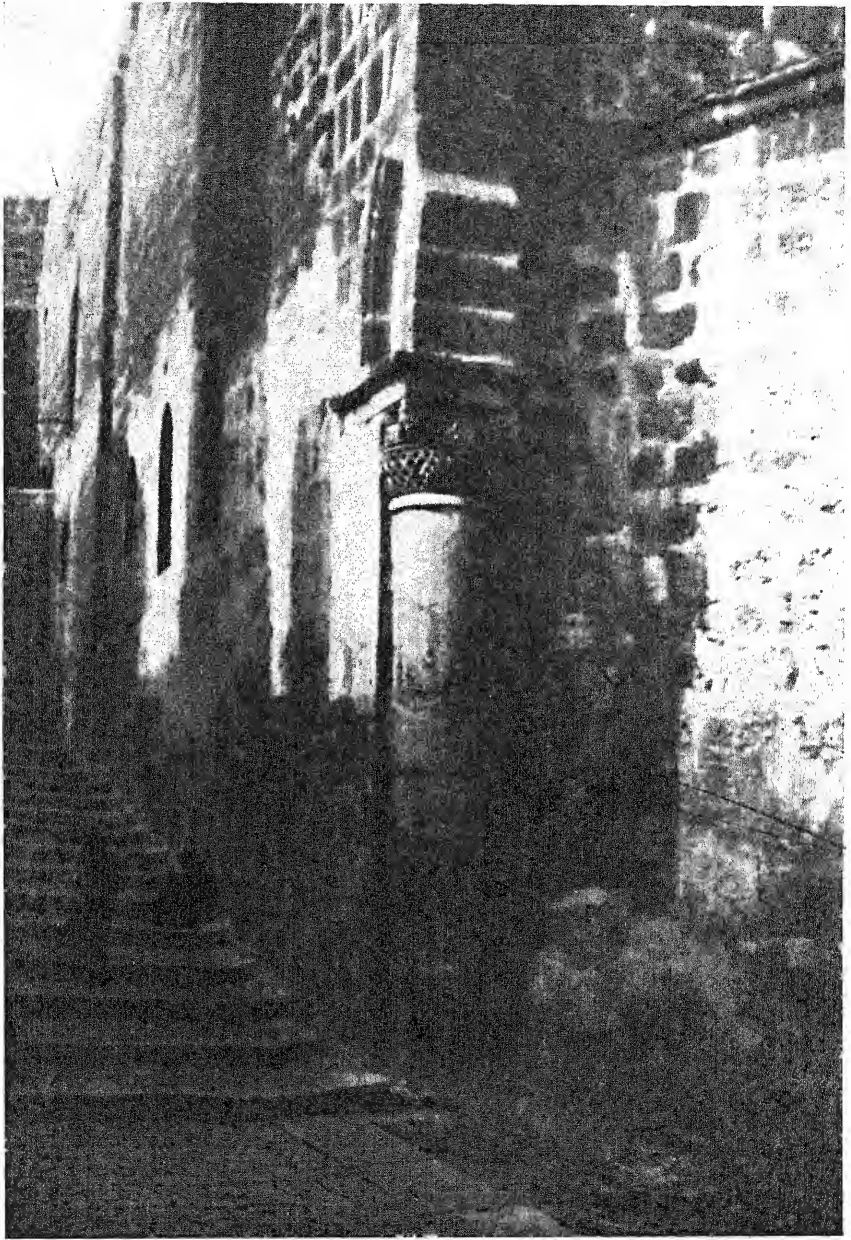
FIG. 62. SOUTH WALL OF CHAPEL OF ST. JAMES

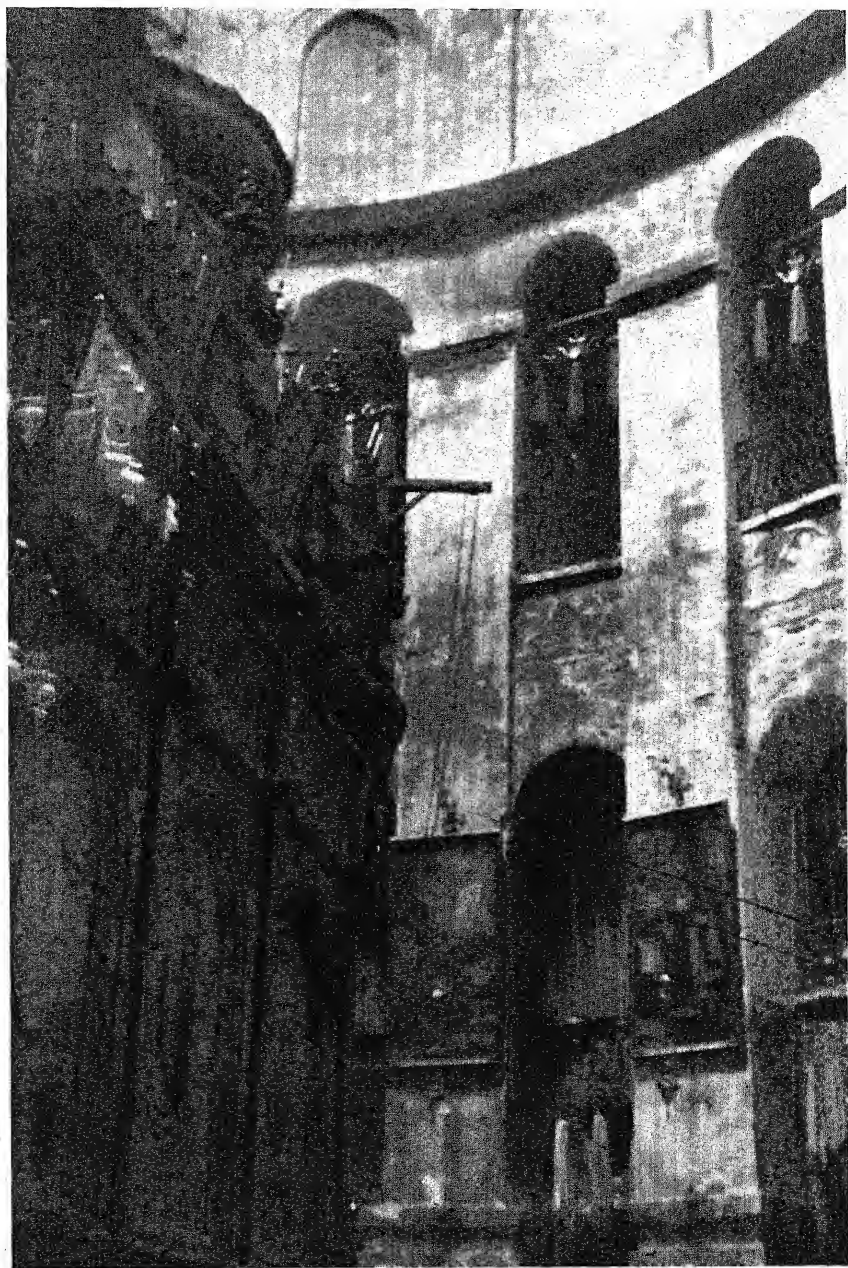
FIG. 64. NORTH-WEST PART OF ROTUNDA

The piers of the main Rotunda (see Fig. I, 13) are now square (see Fig. 64), though they probably enclose as a core the earlier round columns of the building of Constantine Monomach (c. A.D. 1048). The present piers are clamped together with rusting iron (see Fig. 65), are very irregular in shape and size, and are not placed symmetrically beneath the circular drum built in 1867. They are therefore subject to eccentric loading, and all of them show cracks to a greater or less extent; some of these cracks are serious, though certainly due to earthquake shock as well as to thrusts (see Fig. 66).

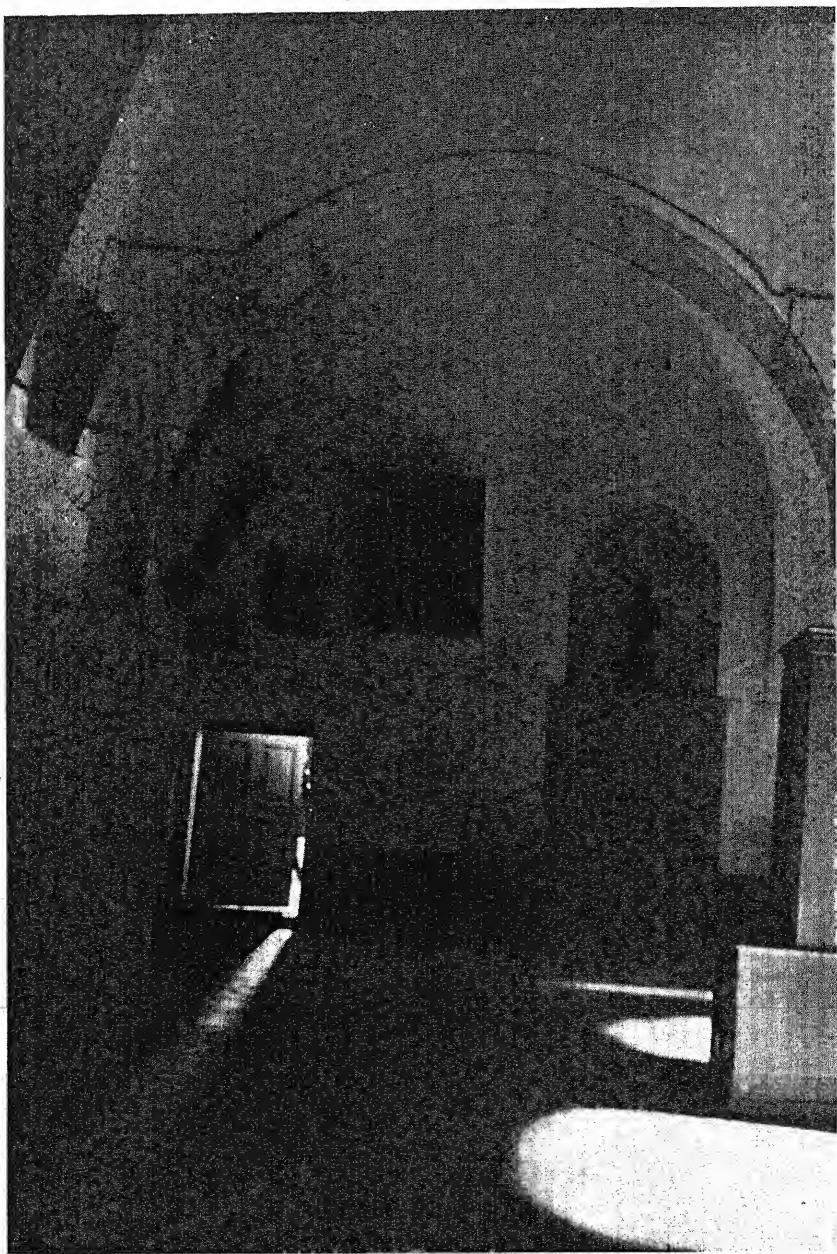
FIG. 67. FRANCISCAN UPPER GALLERY OF ROTUNDA

The galleries of the Rotunda (see Fig. 67) surround the main piers, and are enclosed by a circular wall, whose lower portions date from Constantine's original Anastasis (see Fig. 68). This circular wall leans outwards owing to the thrusts of the gallery vaults and the communicated thrusts of the cone which covered the central space prior to 1808.

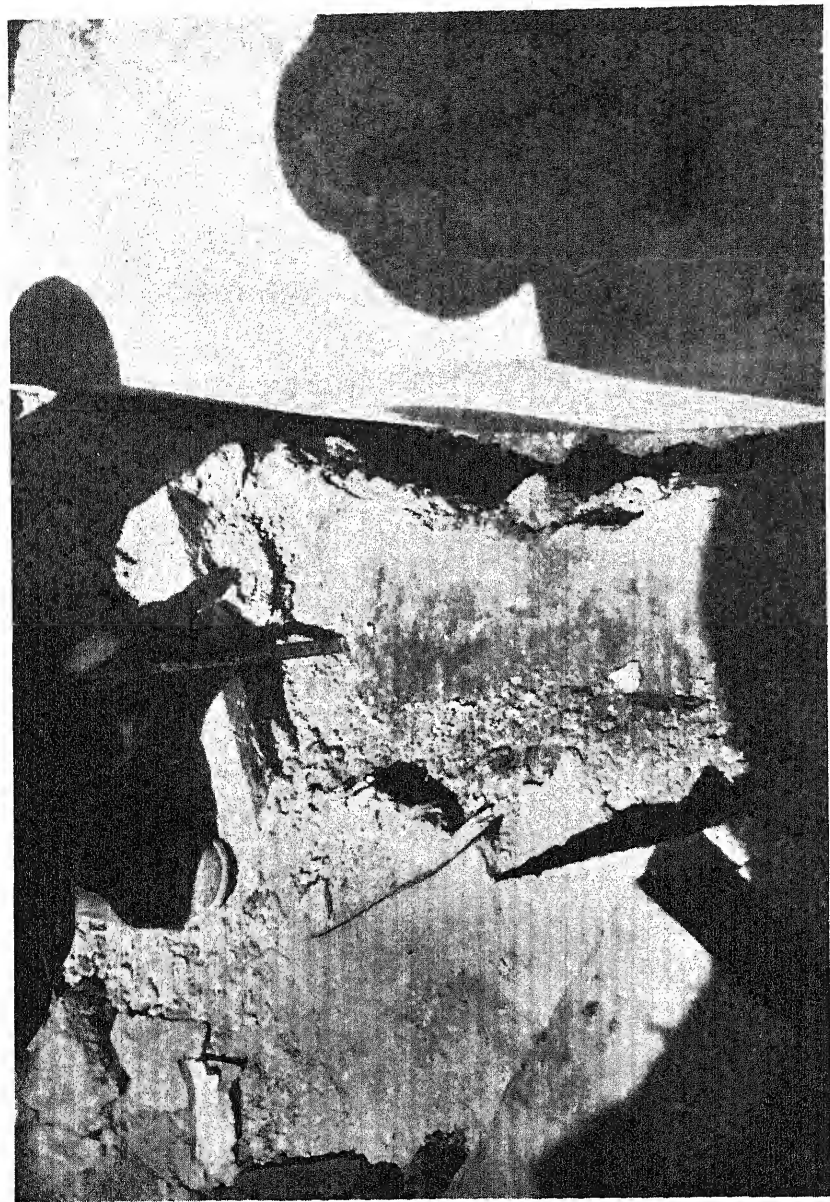
The roofs in general are in a bad state, and allow much rain-water to penetrate to the interior. As previously mentioned this has led to much extra weight being imposed on the building as successive layers of roofing material have been laid (see Fig. 69).

FIG. 69. PORTION OF HIGH VAULT ROOF, SHOWING SUPERIMPOSED
LEVELS OF SLABS

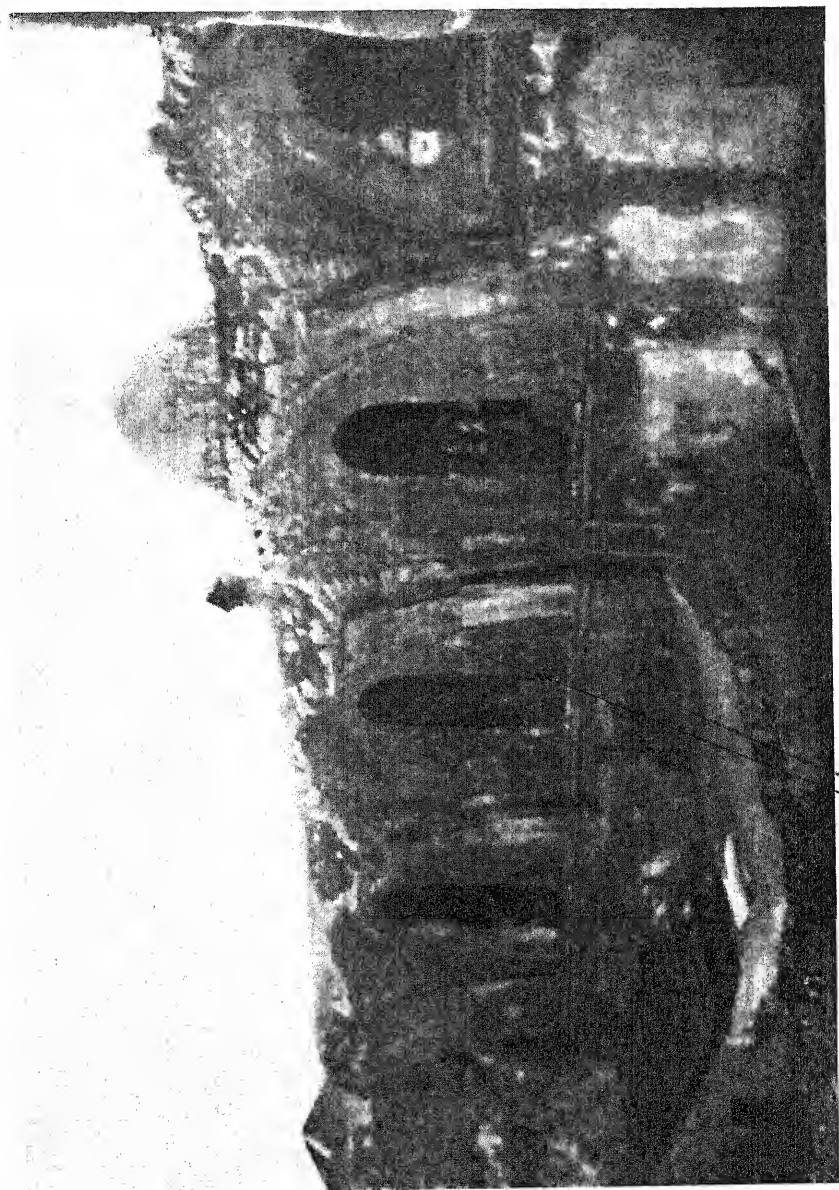
Secondly, the major part of the South wall of the old Latin Refectory (see Figs. 70, 71, II, 14) is in a ruined state, with large masses of overhanging vaulting. These are cracking away from the wall, and there is grave danger of their collapse.

FIG. 70. RUINED SOUTH WALL OF OLD REFECTORY

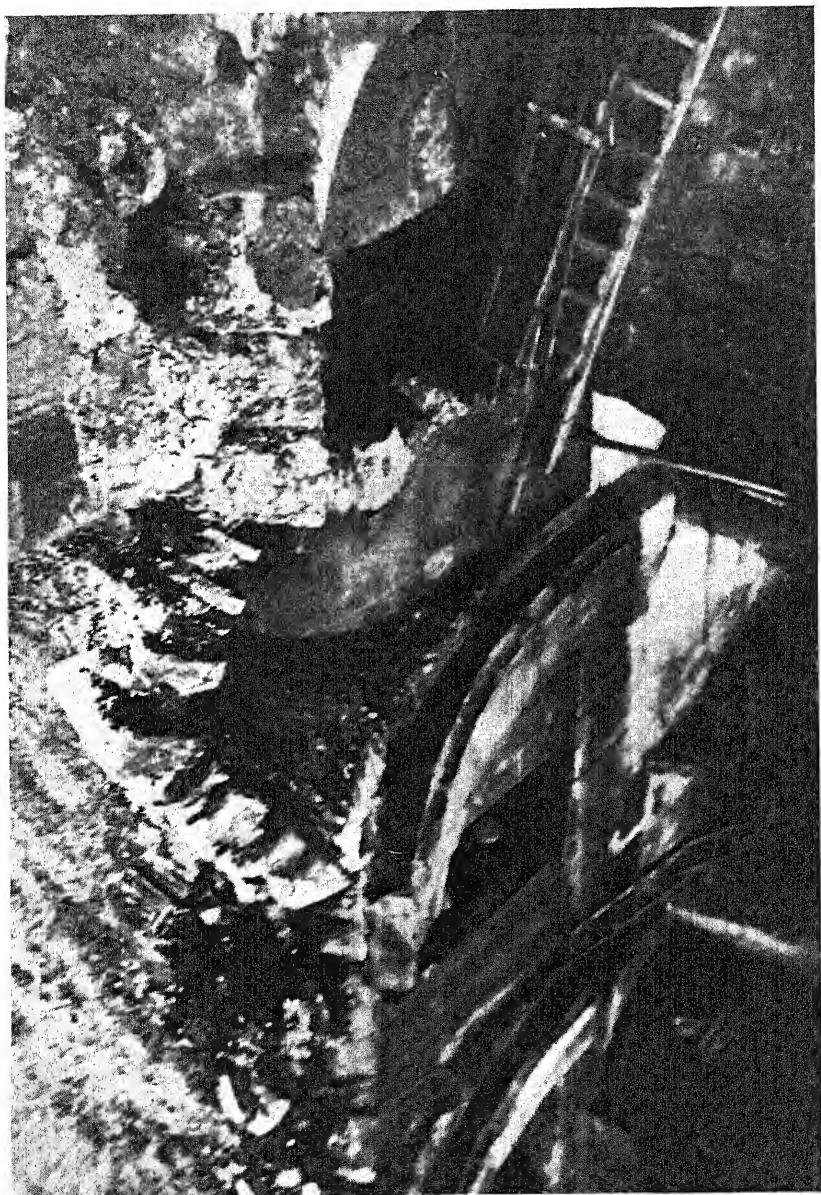
FIG. 71. OVERHANGING VAULT MASSES OF OLD REFECTORY
